The Extraordinary Incidence of Landslides in 2012: Fact or Twiction?

The heavy rains of 2012 saw the media, and social media, report a seemingly astonishing number of landslides across the country, but is this really the case? ask Catherine Pennington and Anna Harrison from the Landslides Team at the British Geological Survey

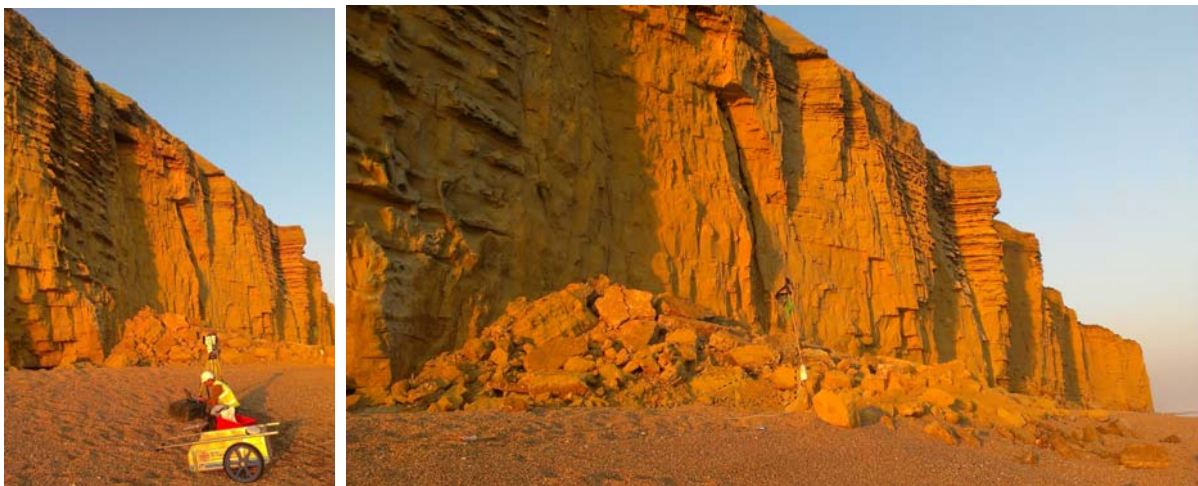
Figure 5 The rock fall at Burton Bradstock. Left: BGS Landslides Team carrying out LiDAR survey of the landslide and cliffs; Right: the landslide debris.

Shortly after 1230 on 24 July 2012, the BGS Landslide Response Team received reports of a large rock fall on the Jurassic Coast at Burton Bradstock in Dorset. There were, in fact, two rock fall events approximately 20 minutes apart. Several people were injured and, tragically, 22-year-old Charlotte Blackman from Derbyshire was killed in the incident. The rock fall was widely reported in the media, including Twitter, and the beach and coastal cliff-top footpath were later closed temporarily to protect the public. There have been rock falls reported and photographed along this section of coast for decades. In February 2012, a couple walking along the same beach narrowly avoided a rock fall probably caused by thawing of a deep frost and another fall came down after heavy rain in January 2013.

The rock fall in July 2012 was likely to have been triggered by a combination of natural factors including prolonged heavy rainfall, coastal erosion, stress release and long-term deterioration of the rock strength by weathering and possibly even thermal expansion; these are natural processes that play a continual role in weakening cliffs. The antecedent rainfall through July had saturated the high porosity sandstone rock increasing its unit weight and raising pore pressures in the slope particularly between the wide open joints and bedding planes, effectively reducing the slope's overall resistance to the downward force of gravity. The rock fall debris ran out by 30m onto the gently sloping gravel beach rapidly depositing a pile of rubble approximately 20 m wide and up to 10 m high.

The 40 m high sea cliffs between West Bay and Burton Bradstock mostly comprise the Jurassic age Bridport Sand Formation, a shallow marine fine-grained sandstone with irregularly placed stronger calcite cemented sandstone beds and lenses that weather to a yellow colour and protrude from the cliff face every metre or so as seen in the photographs. When the Bridport Sand Formation sandstone is dry it is typically a weak to moderately strong rock but once saturated it becomes considerably weaker and this makes these cliffs more susceptible to failure during prolonged periods of wet weather when groundwater levels are elevated and slopes are saturated by rain or melting snow and ice. Most of the landslide deposit was composed of the Bridport Sand Formation with blocks up to 2 m³ in the landslide debris.

Above this rests the Inferior Oolite Group, a three-metre thick sequence of thick limestone beds that form a resistant cap. The presence of widely spaced orthogonal joints generates large (2 m x 2 m x 0.5 m) blocks that are seen in the landslide debris and provide a regular source of fossils for the many fossil hunters who visit Dorset Coast every year. Above this, the cliff is capped by several metres of Fuller's Earth, a grey calcareous mudstone which typically erodes as mudflows that cascade down the cliff onto the beach.

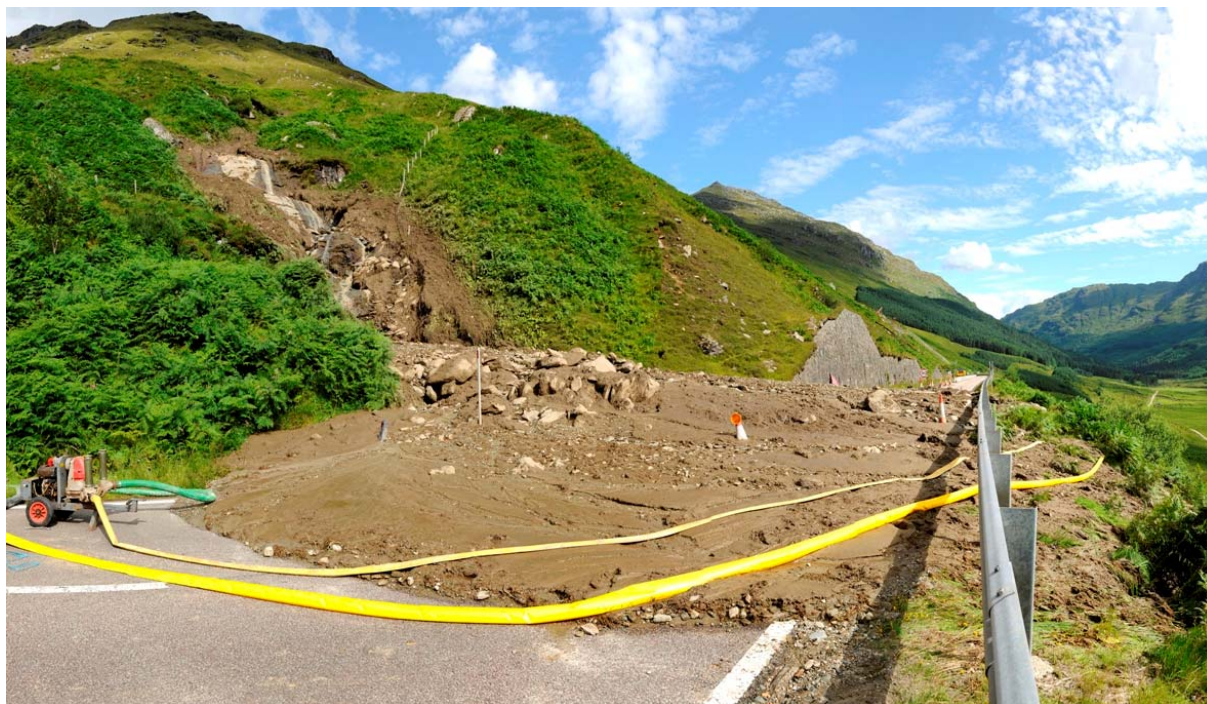
Figure 6 Landslide deposit blocks the road on the A83 Rest and Be Thankful Pass in August 2012

On 1 August 2012 following a period of heavy rain, a debris flow landslide occurred along the A83 Rest and Be Thankful pass in Argyll and Bute. It was reported that 50 to 100 tonnes of material blocked the road that was subsequently closed in both directions.

While this may not be a large landslide in context with the rest of the country, its impacts are disproportionately large. The Rest and Be Thankful Pass is near the bottom of a slope prone to debris flows that have caused the closure of this road on numerous occasions over the past few years. The significance of this road is that its closure results in a 55-mile detour affecting residents, commuters and businesses in the area. It is thought to cost the local economy £50,000 for every day it is closed, and the likely cost to find a permanent solution to the problem could be as much as £520 million⁴.

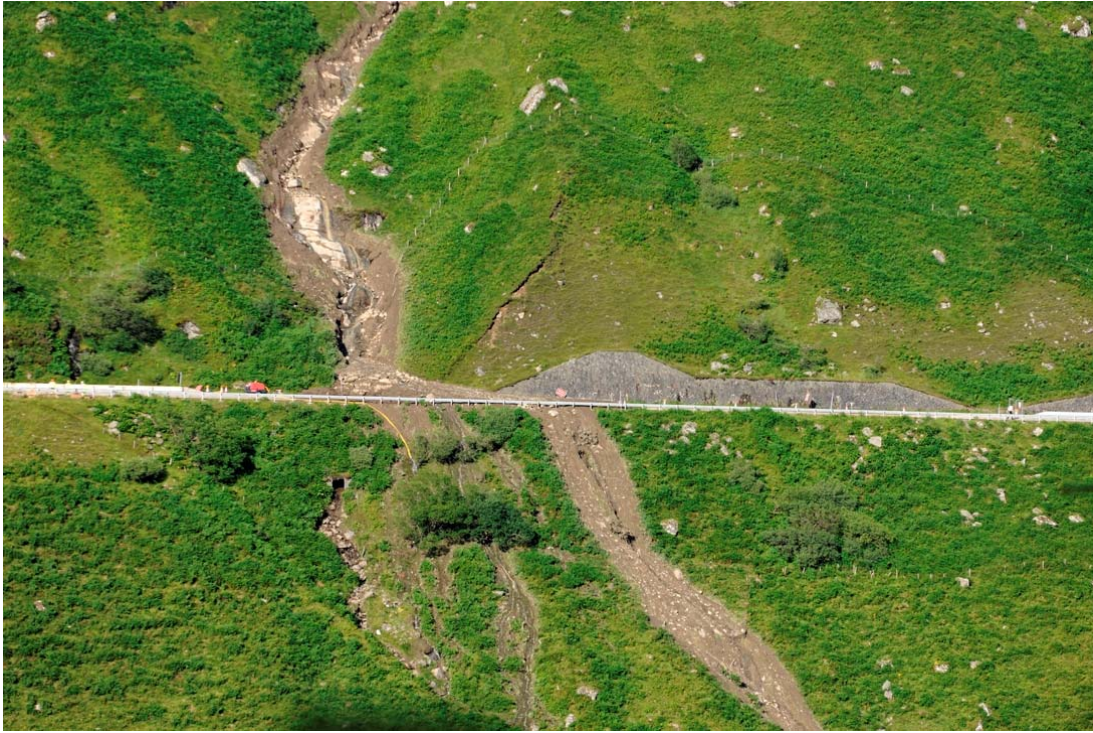
Figure 7 The debris flow path above and below the A83 Rest and Be Thankful pass in August 2012

These debris flows occur on steeply sloping ground underlain by neoproterozoic rocks of the Beinn Bheula Schist Formation, comprising very strong psammite and semi-pelite rocks that are metamorphic in origin and composed largely of quartz, feldspar and mica minerals that are commonly intensely foliated and spectacularly folded. The bedrock plays relatively little part in the landslide activity on these slopes, however, and the recent debris flows have largely been associated with slope deposits, including peat and topsoil, as well as the underlying layers of colluvium. Colluvium deposits on this slope represent earlier phases of slope instability and comprise sandy to gravelly silts and clays, with varying amounts of cobbles and boulders. It is also likely that conditions may have been exacerbated by the additional input of water from bedrock pathways, where jointing or fracturing occurs, due to groundwater flux from the heavy rain leading up to the event.

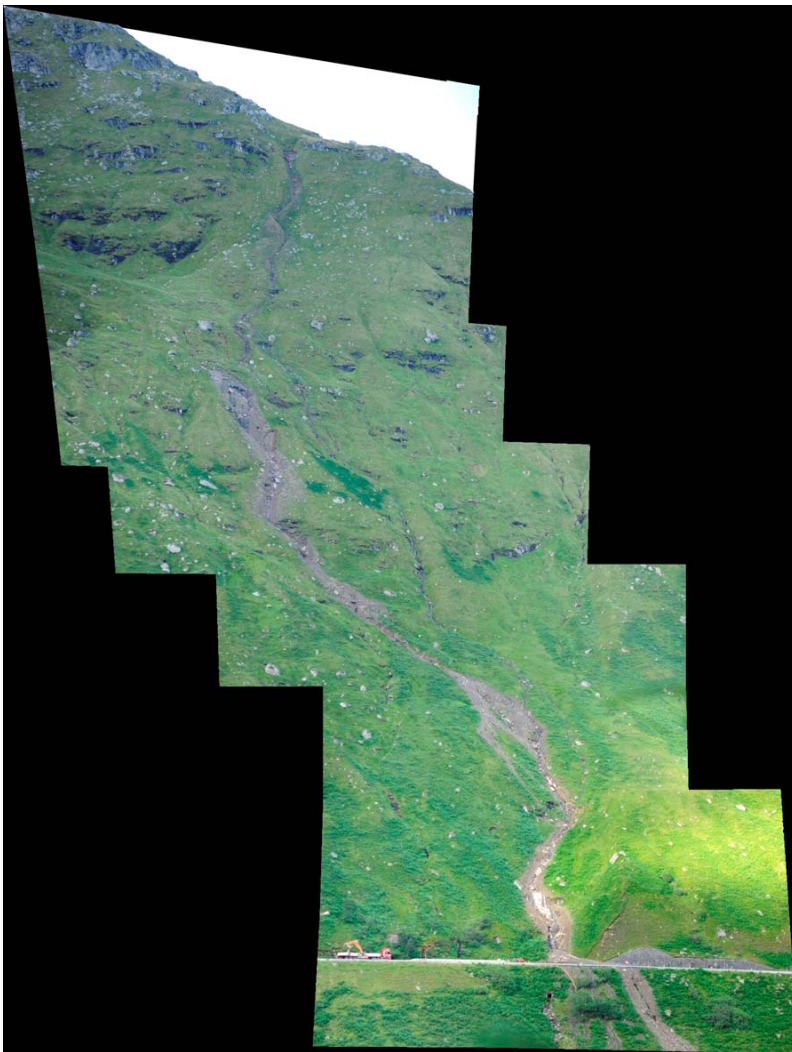
Figure 8 The path of the debris flow on the Rest and Be Thankful Pass in August 2012
